**BA-2417**

**Hellman House**

**1808 Sutton Avenue**

## Maryland Inventory of Historic Properties Form

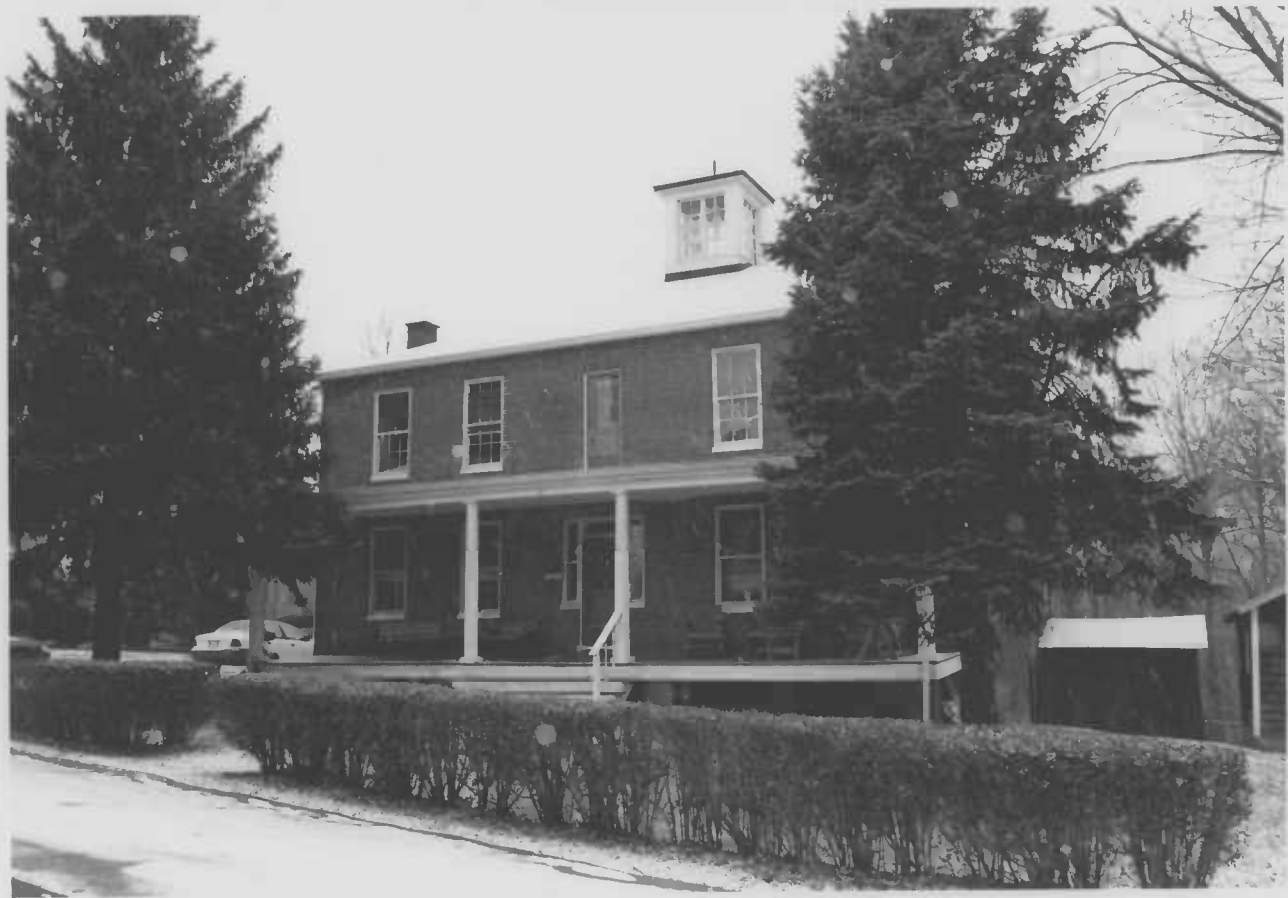
1 of 11

NORTHEAST ELEVATION

The first story of the façade of the Hellman House (northeast elevation) exhibits a central entrance illuminated with a 1-light transom and flanked by 1/1 wood-sash sidelights. The first story features four 6/6 windows and the second story is pierced with four 6/6 windows and one single-leaf door. The central door on the second-story led to a balcony above the one-story porch that is no longer extant. This entrance contains a 9-light over 2-panel wood door. Each of the openings on this elevation are supported with square wood sills and jack arch lintels. The flat roof porch across the full-width of the façade is supported with Tuscan columns. The wood deck of the porch rests on a brick pier foundation.

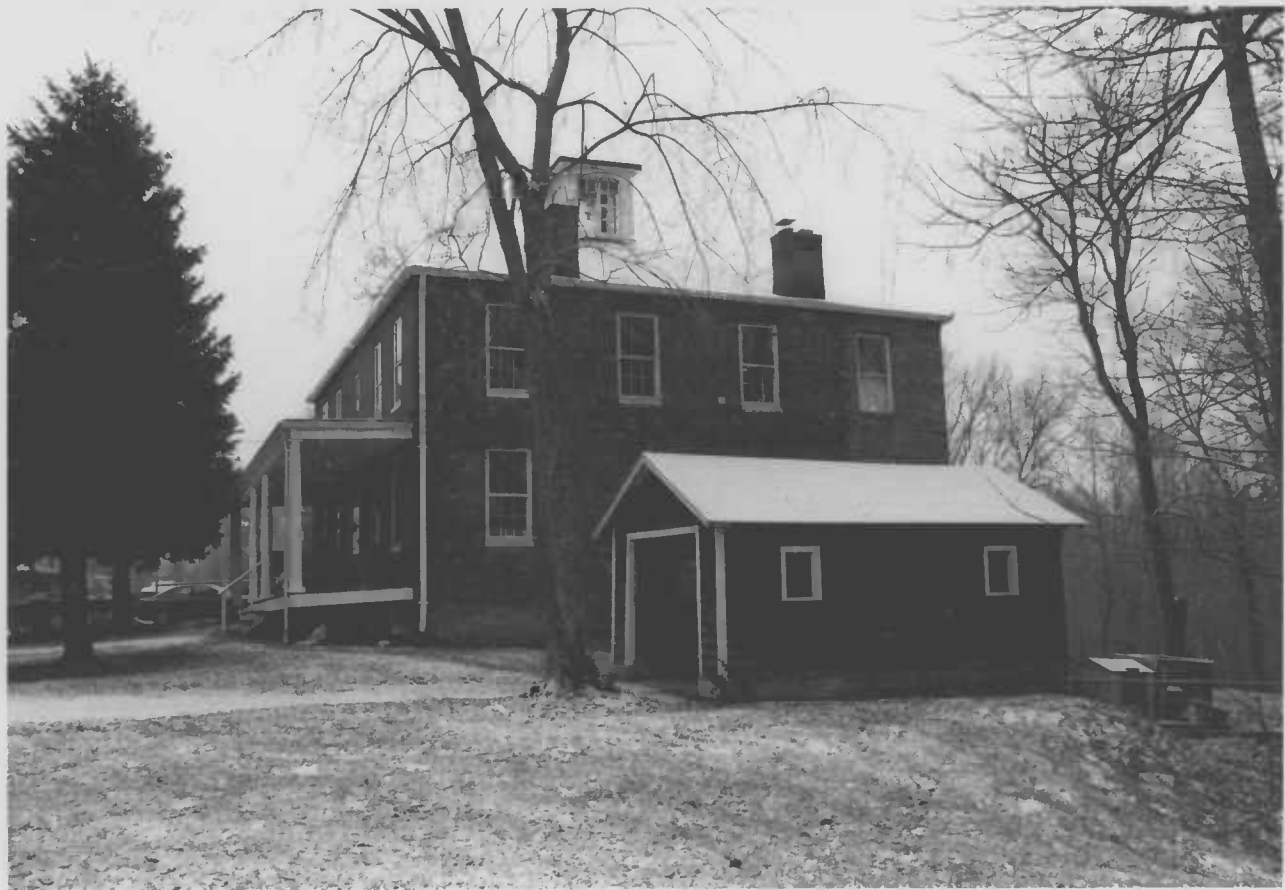
2 of 11

NORTHWEST ELEVATION

The northwest elevation of the Hellman House features window openings on three levels. The basement story exhibits one 6/6 window. The first and second stories are pierced with two and four 6/6 windows respectively. The rear window openings on both the first and second stories is supported with soldier lintels and rowlock sills. The remaining windows have jack-arch lintels and wood sills. The northwest elevation of the summer kitchen is pierced with two multi-light wood-sash windows. The poor condition of these windows does not allow a determination of the number of lights each sash contained.

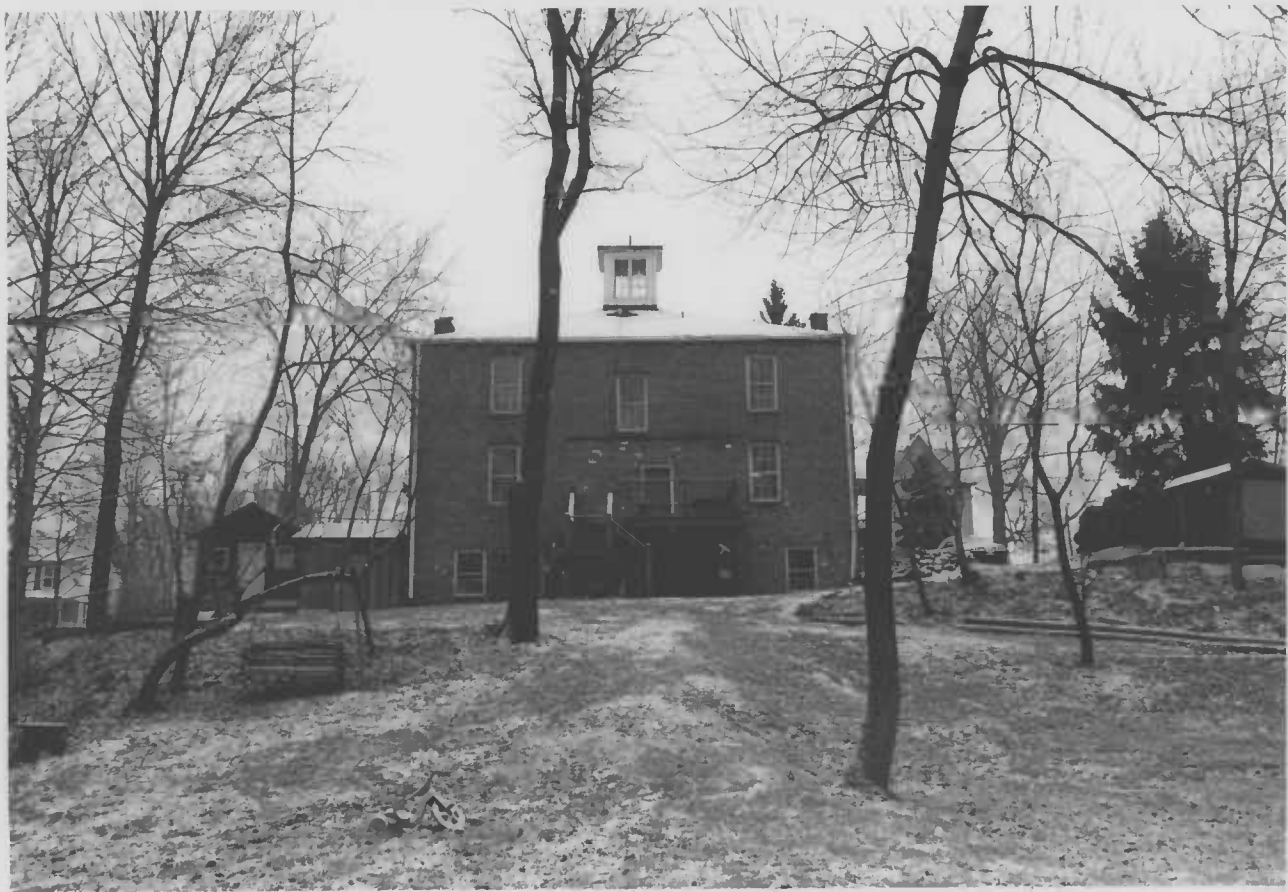
3 of 11

SOUTHWEST ELEVATION

The rear elevation (southwest) of the Hellman House is three stories in height due to the slope of the landscape. The basement level is pierced with three 6/6 windows and a single-leaf 9-light over 2-panel wood door. The first story features two 6/6 windows and one single-leaf four-paneled wood door. The second story is pierced with three 6/6 windows the center of which is slightly lower than the flanking windows. Each of the windows features soldier lintels and rowlock sills. A ghost outline of a porch roof is visible above the first story center bay. A non-historic wood deck provides exterior access to the first story entrance on southwest elevation. The southwest elevation of the summer kitchen has one vertical-board pull-down door.

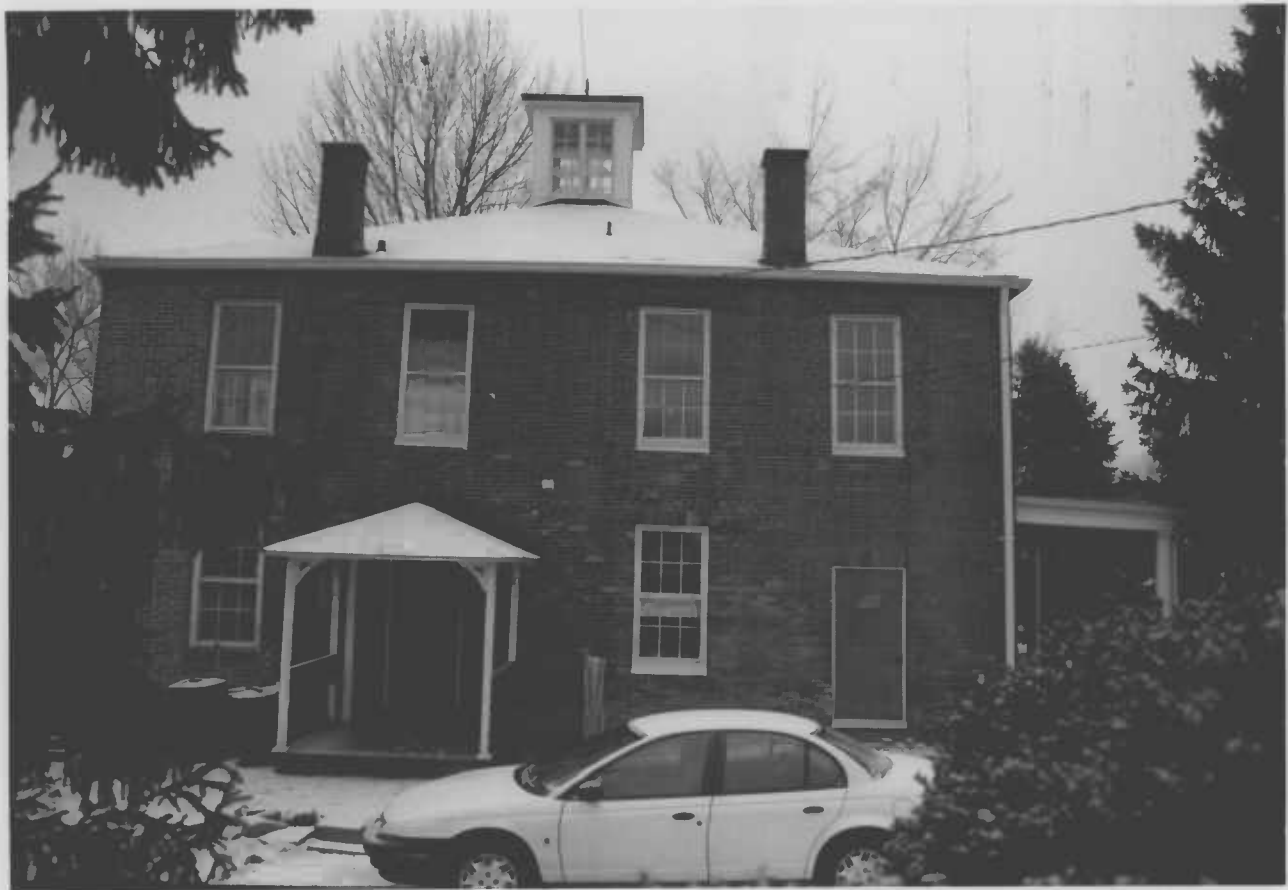
4 of 11

SOUTHEAST ELEVATION

The first story of the southeast elevation exhibits a window, door, window, door configuration with 6/6 windows and single-leaf doors. The rear door is a 12-light over 2-panel wood replacement door. The northernmost door, called a 4-panel coffin door, is original and is wider than any of the other four exterior doors. This threshold to this door originally was set approximately three feet above ground. The second story is pierced with four 6/6 windows. The southernmost windows on the first and second story have rowlock sills and soldier lintels whereas the remaining windows feature jack-arch lintels and wood sills. Covering the

southernmost doorway is a half-hipped roof portico. The portico is supported with square posts with corner brackets and the roof is covered with asphalt shingles.

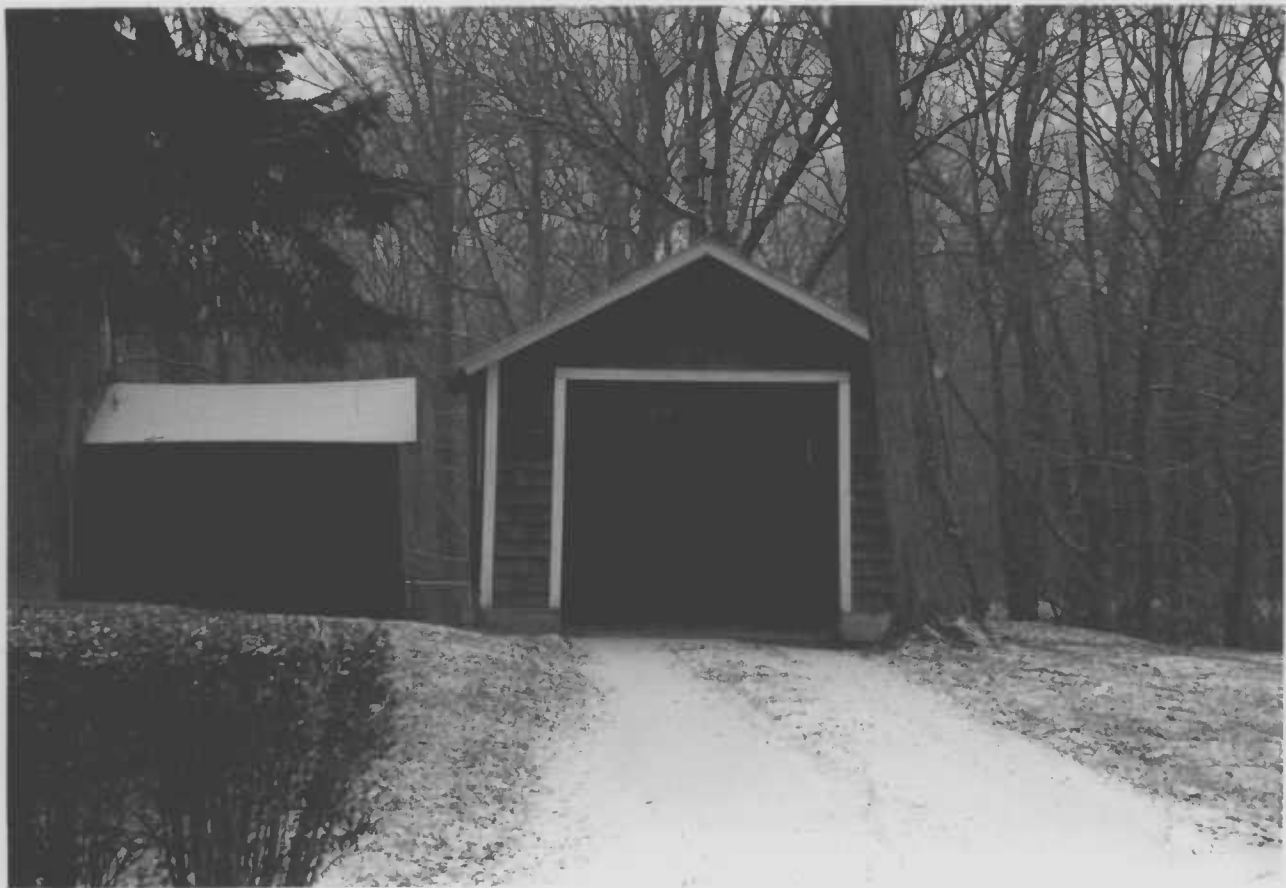
5 of 11

GARAGE, NORTHEAST ELEVATION

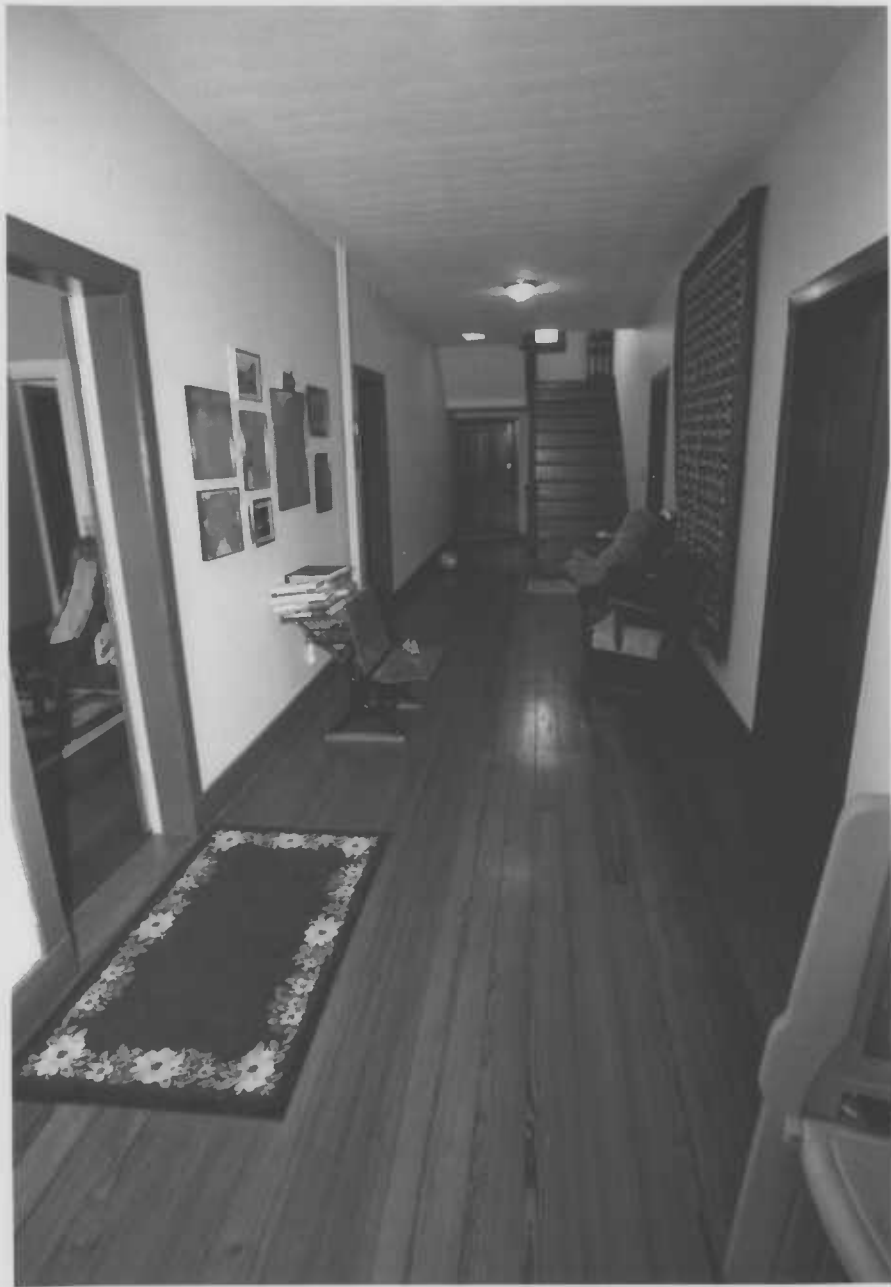
6 of 11

FIRST FLOOR, HALL, VIEW LOOKING SOUTHWEST

The Hellman House features a double-pile plan with a central passage. To the rear of the center hall is the dog-leg stair to the second story. Underneath the stair is access to a descending stair to the basement. The open-stringer stair features a turned and tapered newel post, a round rail, and rectangular wood balusters. The original yellow pine random-width floorboards are tongue-and-groove and the ceiling and walls are covered with lath and plaster. Around the perimeter of the hall is the original six-inch-high fascia baseboard. Each of the doors features a square-edged four-inch-wide casing with an astragal molding and are four panels each. The front and rear exterior doors are both four-panel doors with iron lock boxes and wood knobs. The panels are raised and lack molding details. The descending stair underneath the main stair in the hall is accessed through a vertical-board door. The only door with moldings is the parlor door. The profile consists of a cyma recta and a cyma reversa separated by a fillet with a slightly raised panel. Many of the original doorknobs in the entire house have been replaced either with porcelain or clear crystal knobs. The hardware for a service bell to the second floor exists in the center hall.

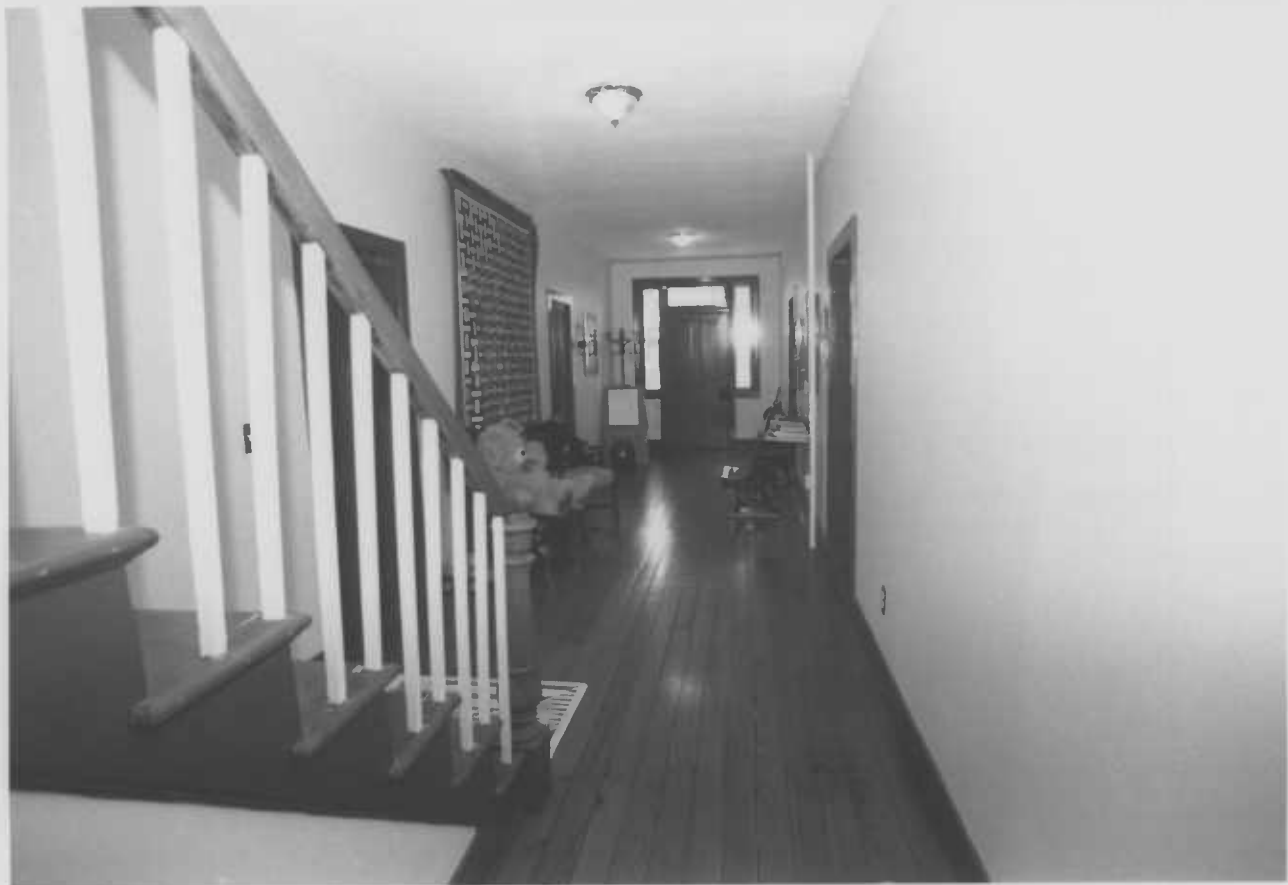
7 of 11

FIRST FLOOR, HALL, VIEW LOOKING NORTHEAST

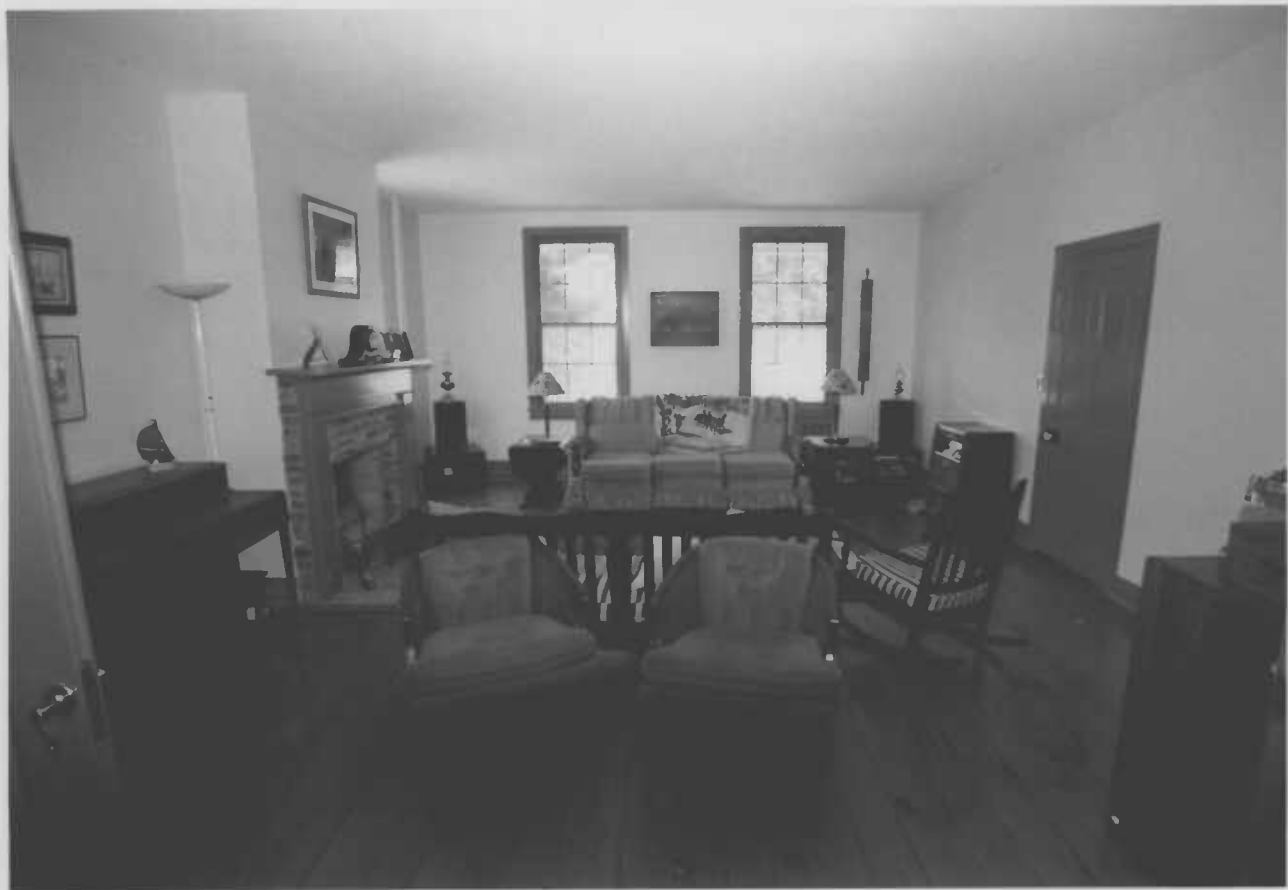
8 of 11

FIRST FLOOR, LIVING ROOM, VIEW LOOKING NORTHEAST

Much of the historic fabric throughout the Hellman House is intact with features similar from room to room. Separating the front hall is a two-leaf pocket door of four raised panels each with replacement handles. The living room (historically called the hall) and the dining room have similar materials as the center hall including floorboards, walls, ceiling, casings (same for both the doors and windows), and doors. The baseboard is similar to the hall with the addition of a non-historic shoe molding. Each chimney breast extends into the room and features a brick hearth repointed with Portland cement. Each fireplace features a simple Classical-style mantel and replacement fire bricks. Underneath the mantel shelf is an ovolo molding and the pilasters have a splayed capital and a plinth. Radiators have been installed in both rooms.

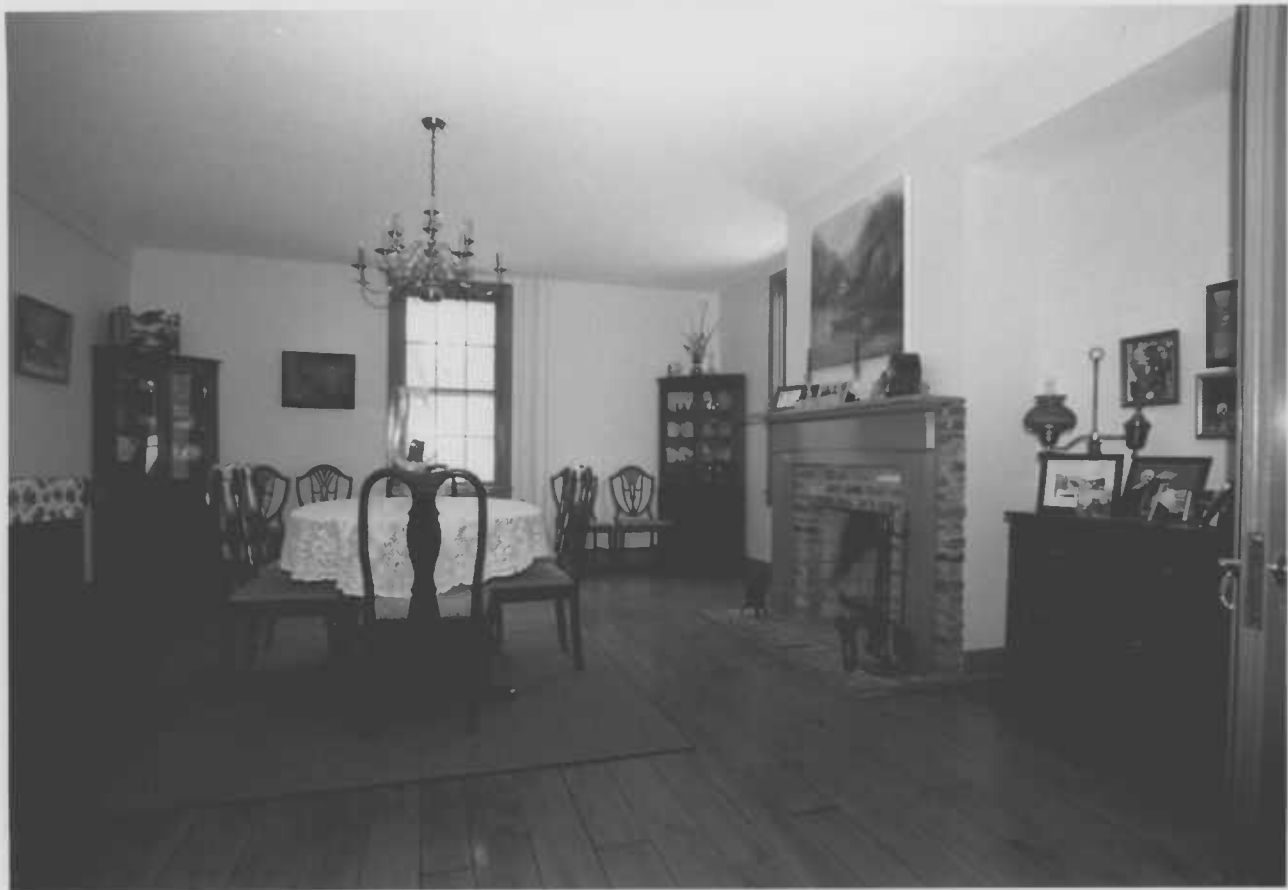
9 of 11

FIRST FLOOR, DINING ROOM, VIEW LOOKING SOUTHWEST

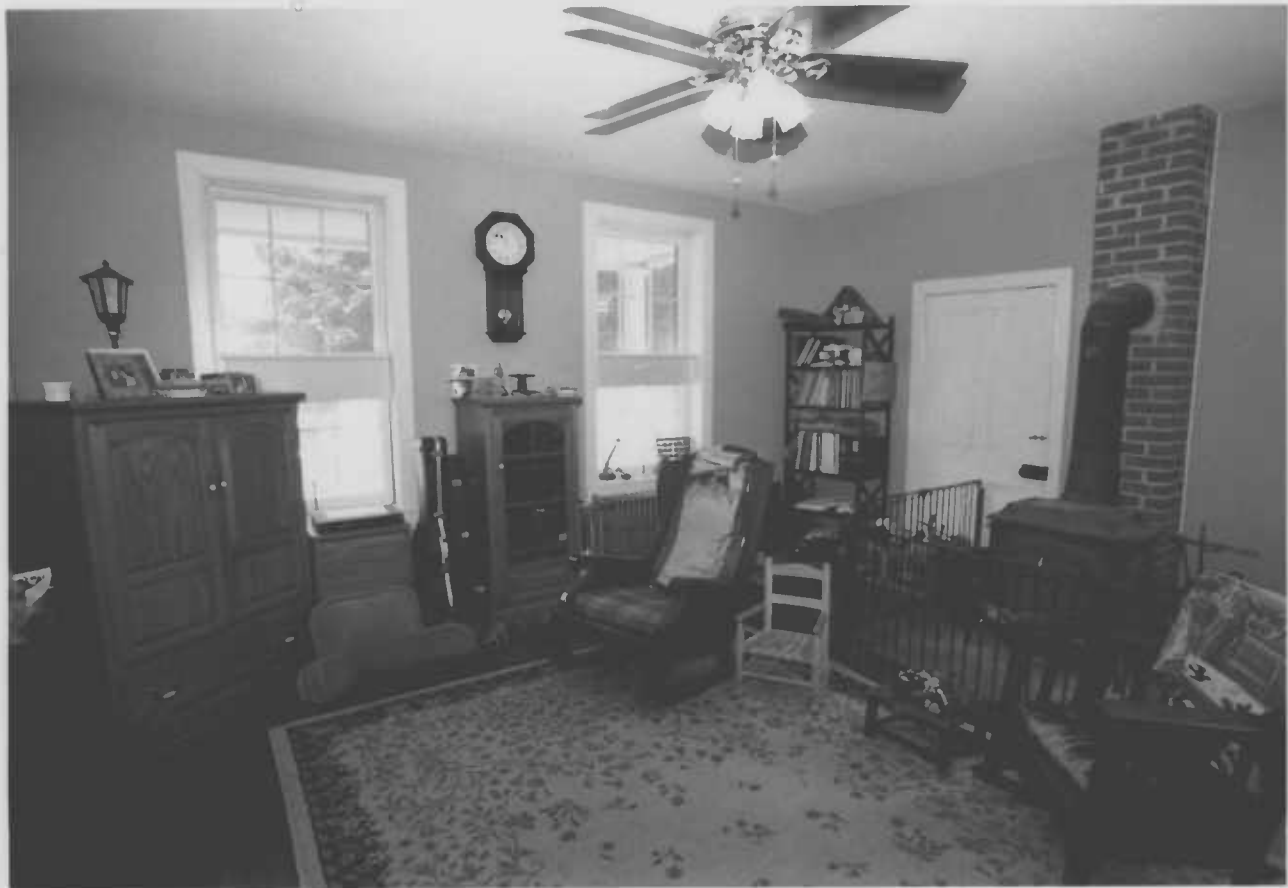
10 of 11

FIRST FLOOR., PARLOR, VIEW LOOKING EAST

Original materials in the parlor that are the same as the hall include the floors and casings. The baseboard is similar with the addition of a non-historic shoe molding. The coffin door on the southeast wall has four raised panels and a wood doorknob. A wood-burning stove and gas radiators have been installed in this room.

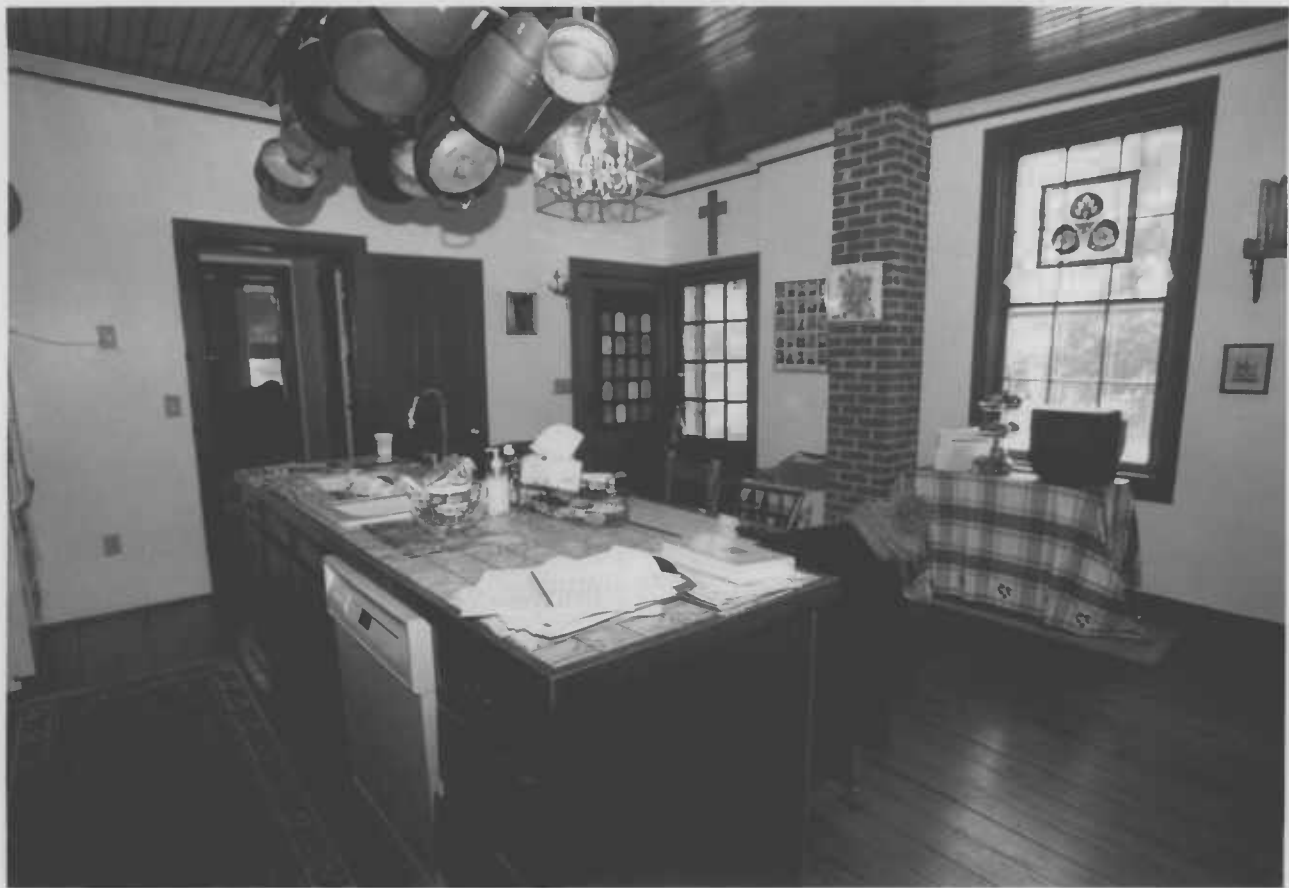
11 of 11

FIRST FLOOR, KITCHEN, VIEW LOOKING EAST

The southeast corner room of the Hellman House has been altered in order to add a bathroom on the first floor. A bathroom, side hall, and a closet are located in between the parlor and the kitchen on the east side of the dwelling. The side hall and kitchen have similar materials as the parlor including the floorboards, lath and plaster walls, baseboard, and window and door casings. The kitchen ceiling has been replaced with thin wood grooved boards. The bathroom door is a 4-panel door and the pantry door in the kitchen is a grooved vertical-board door. The kitchen features an exposed replacement chimney. Not original to the kitchen is the crown molding with a double cyma recta molding profile. Non-historic cabinets have been installed in the kitchen.
